# SolvAir

SolvAir's tailored air solution eliminates system-clogging waste in Saica Pack UK's BOBST machine.

# SolvAir's advanced Air Solutions ensures uninterrupted production lines for international manufacturers.

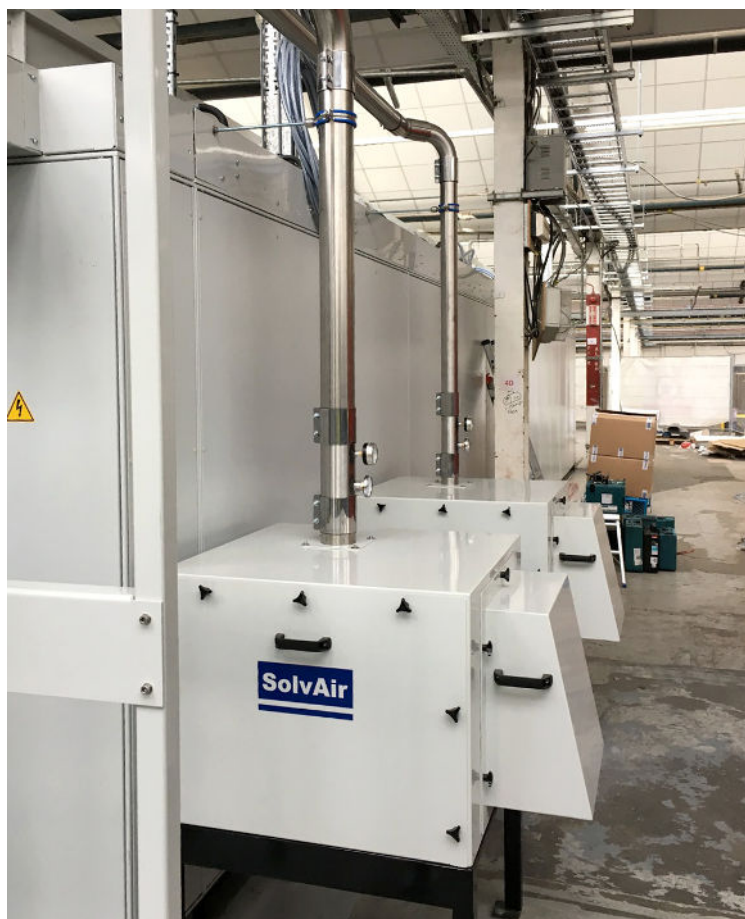
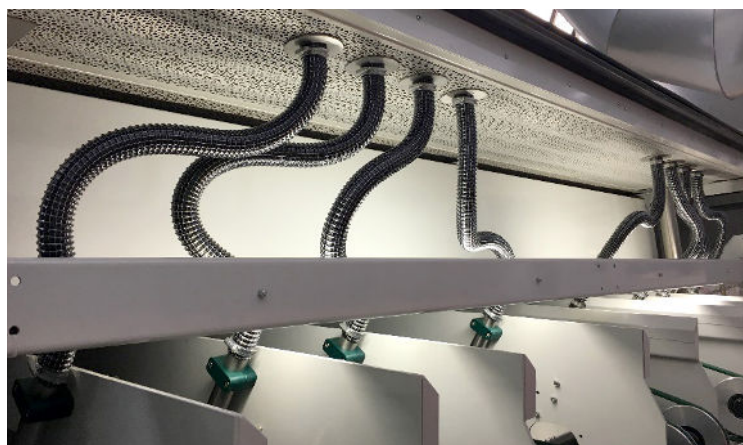
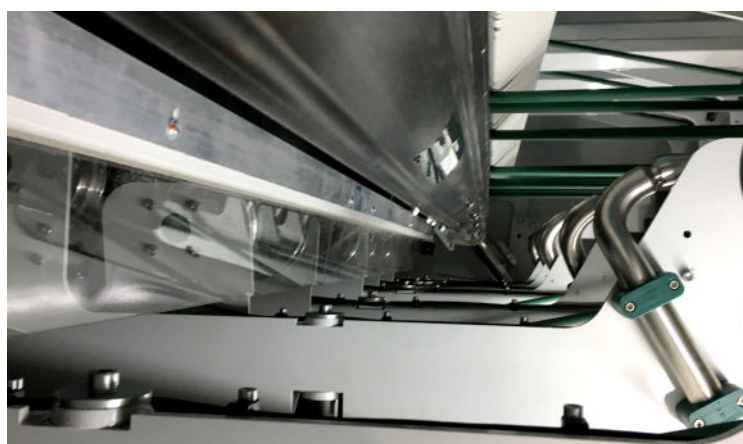
#### Final Installation

SolvAir's bespoke Air Curtain System, featured a 2800mm dual inlet Air Knife and eight strategically placed SV10 nozzles. This comprehensive solution integrated seamlessly with the existing BOBST machine controls, effectively eliminating waste material blockages.
